Post-Flood Recovery Assessment and Stream Restoration Guidelines for the Colorado Front Range

Eric E. Richer, Matt C. Kondratieff, and Benjamin D. Swigle

Colorado Parks and Wildlife, Fort Collins, Colorado

April 29, 2015

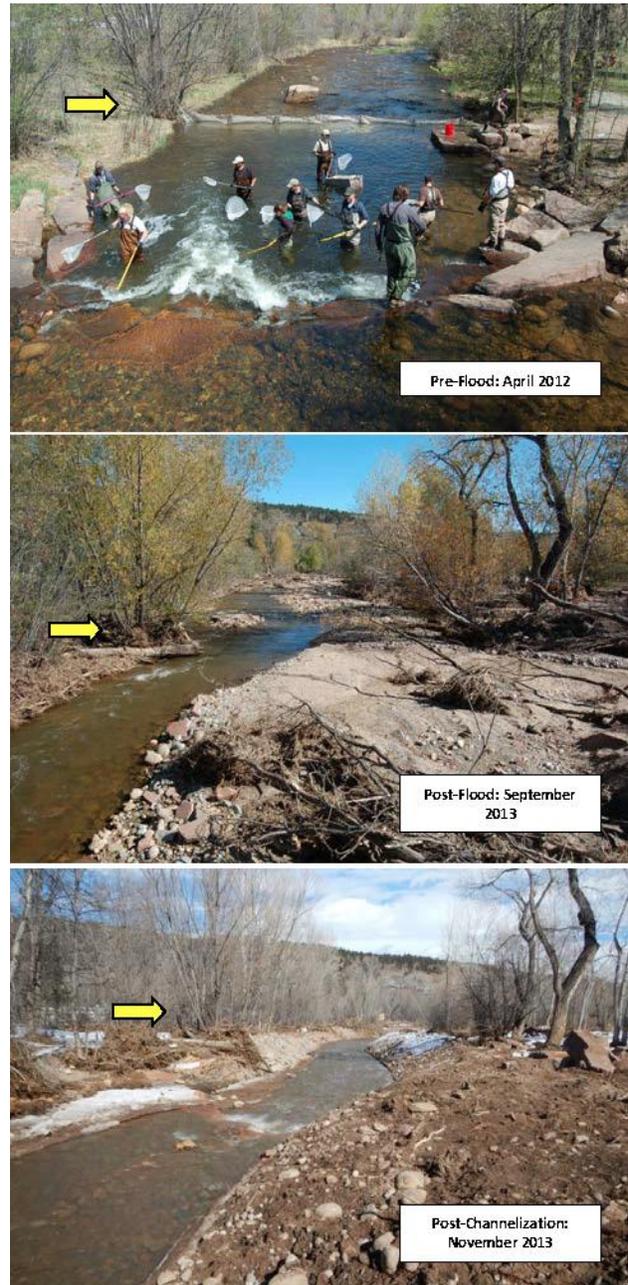
Figure 1. Pictures of the South Fork of St. Vrain Creek through Bohn Park showing pre-flood condition, post-flood condition, and post-channelization condition.

The yellow arrow denotes the same river birch.

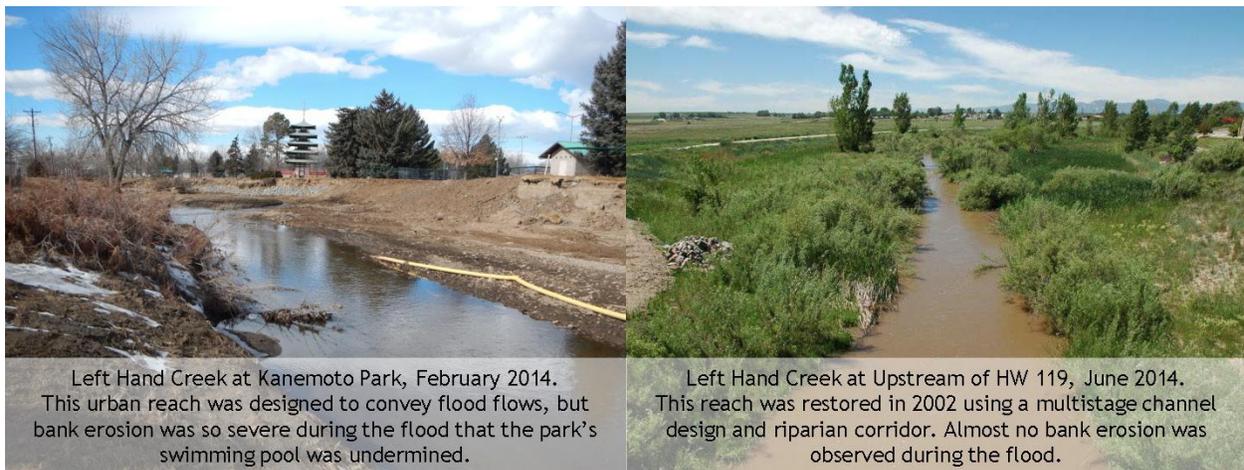
Figure 2. Pictures of the two locations on Left Hand Creek illustrating the value of multistage channel designs and functioning riparian corridors for flood conveyance and channel stability.

This issue with trapezoidal channel failure is illustrated by two contrasting reaches on Left Hand Creek (Figure 2). The upstream reach is an urban site near Kanemoto Park with a trapezoidal and armored channel designed to convey floods. The Kanemoto reach experienced substantial bank erosion during the flood. Bank erosion was so severe that the park’s swimming pool was undermined. The bank erosion observed at Kanemoto Park is a stark contrast to a downstream reach near Highway 119. The reach near Highway 119 was restored in 2002 using a multi-stage channel design with a functional floodplain, and almost no bank erosion was observed at this site during the flood (Figure 2). The stark contrast between these sites also extends to the cost of reconstruction and habitat restoration. The Kanemoto reach will require substantial investment to stabilize and restore the river channel, whereas the Highway 119 reach will require no funds for stabilization or restoration. This example illustrates the value of riparian floodplains for flood conveyance, channel stability, and protection of property and infrastructure.

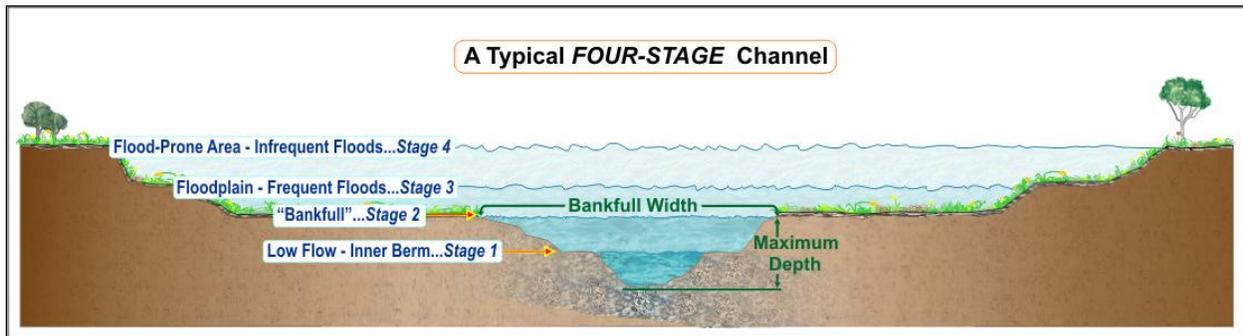
Figure 3. A typical four-stage channel design for a C4 stream type in a Valley Type VIII (Used with permission from D.L. Rosgen).

There is a new paradigm in river engineering that embraces riparian floodplains as the most effective and sustainable means to convey floods and dissipate energy. Natural channels typically contain multiple stages that are inundated at different flows. For example, a four-stage channel includes (1) a low flow channel that maintains habitat during baseflows, (2) the bankfull or active channel, (3) a riparian bench to convey frequent floods, and (4) a flood-prone area between terraces to convey infrequent floods (Figure 3). We commend emergency work conducted by the CWCB, Colorado Department of Transportation (CDOT), and Natural Resource Conservation Service (NRCS) that incorporated multi-stage channel designs, but there are also many examples of trapezoidal, single-stage channels constructed after the flood. These trapezoidal channels create over-wide conditions with poor habitat quality. In nature, the trapezoidal channel often appears as an intermediate step following a disturbance that serves as a transition toward a stable end point. The length of time needed to reach a stable form depends on a range of factors including geomorphic context, vegetation, and number of steps within a channel evolution sequence. During low flows, over-wide channels create shallow conditions that elevate water temperatures and decrease dissolved oxygen. In addition, over-wide conditions often induce aggradation of sediment because the channel lacks the capacity to transport the incoming sediment load. During floods, over-wide channels concentrate energy, which increases water velocity and accelerates bank erosion. Multi-stage, or nested, channel designs provide a means to create naturally stable channels that convey floods and provide quality habitat for aquatic

organisms. During emergency reconstruction, multi-stage dimensions can be “roughed-in” thereby reducing the cost of permanent stream restoration efforts.

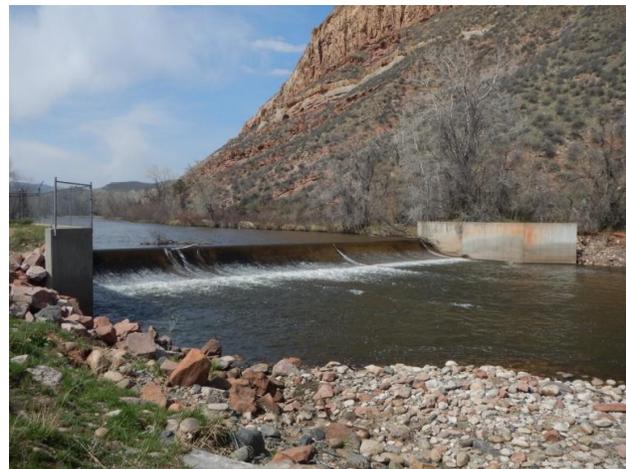
Figure 4. Diversion structure at the Watson State Wildlife Area, Cache la Poudre River.

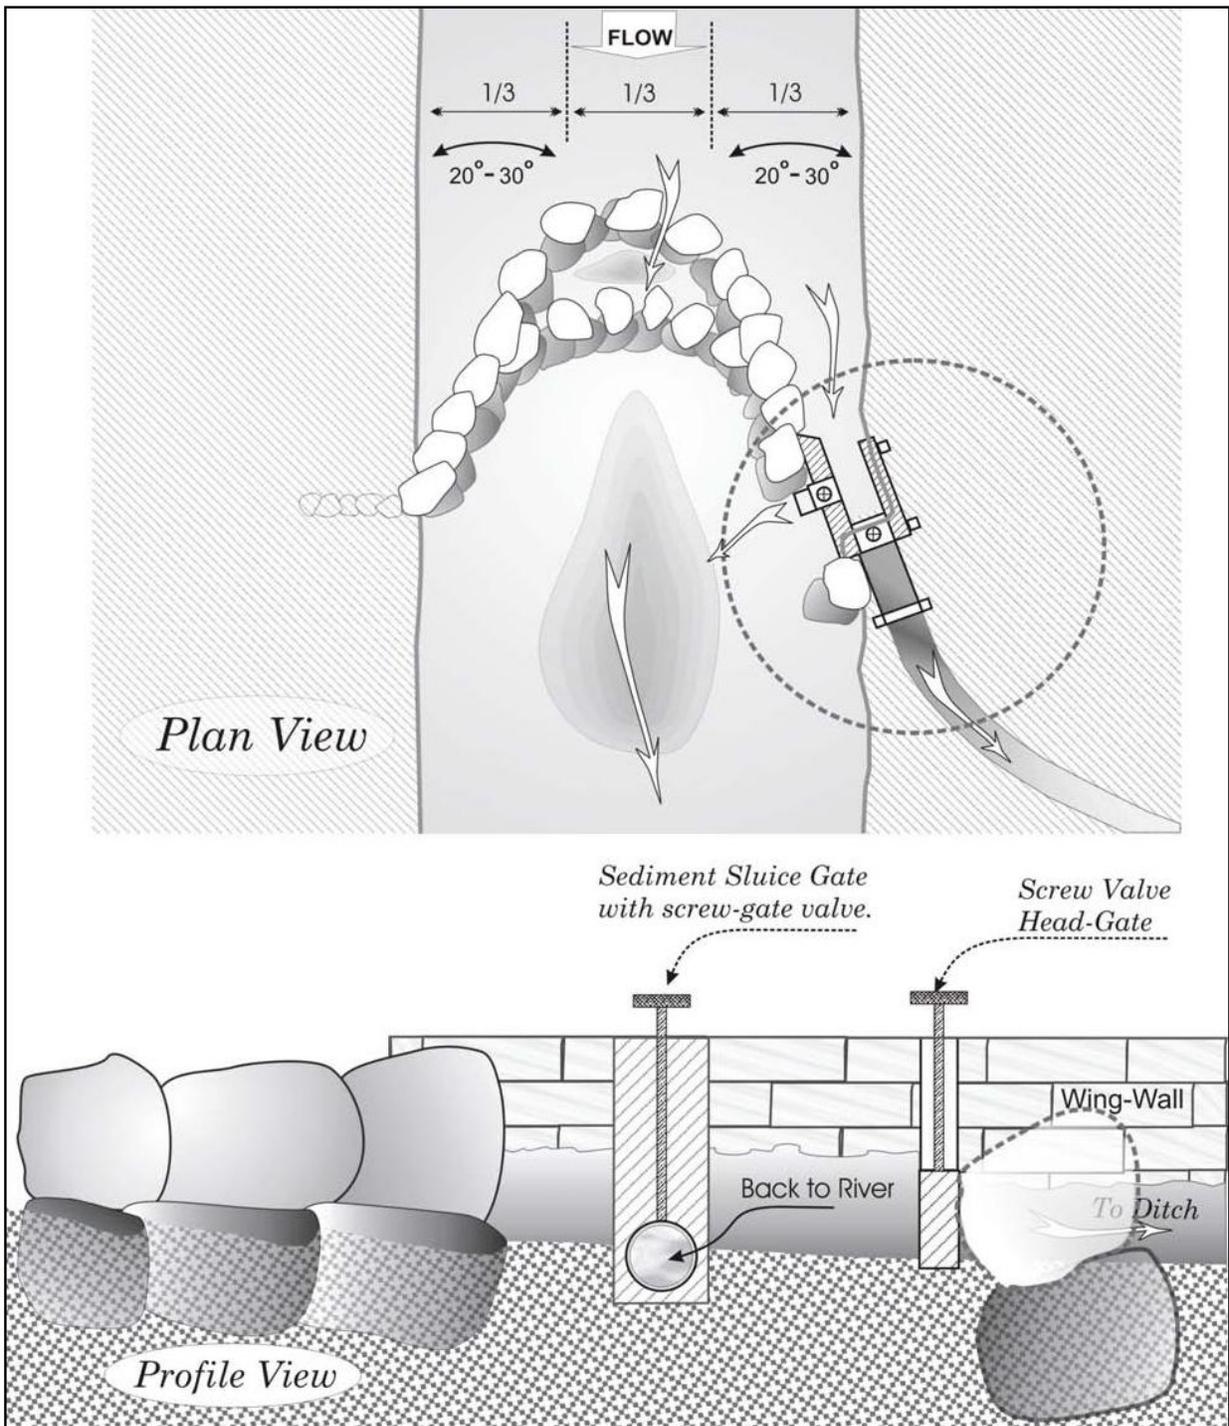
Figure 5. Conceptual example of a cross-vane diversion structure with irrigation head gate and sediment sluice (Rosgen, 2006).

These permitting and funding issues may have prevented ditch companies from considering alternative diversion designs recommended by the CWCB and CPW, such as the cross-vane diversion structure (Figure 5). These structures have not been widely used in the Colorado Front Range, but have been successfully and broadly applied in western Colorado to divert water and provide grade control while accommodating the passage of sediment, fish, and boats. Furthermore, these structures are often cheaper to build and repair than the traditional low-head concrete dam. These alternative structures may not have qualified for the agricultural exemption from the ACOE because they departed from the "character, scope, or size" of the original design under the maintenance exemption. However, the cross-vane structure is included under the Regional General Permit No. 12, which could expedite the permitting process for these structures in Colorado. We recommend that state and federal agencies work with the ACOE to identify permitting options for incorporating alternative diversion designs into emergency flood response.

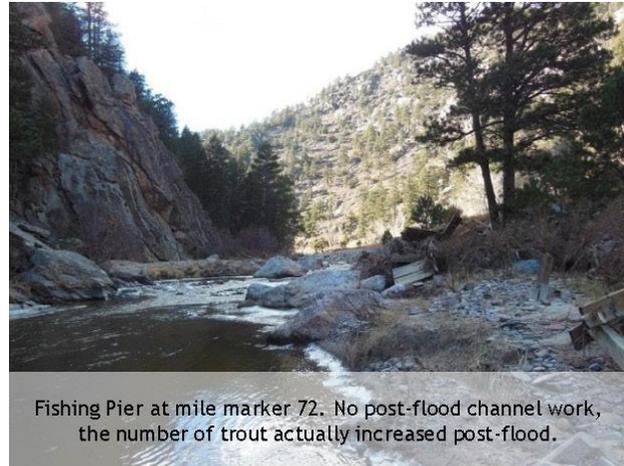
Fishing Pier at mile marker 72. No post-flood channel work, the number of trout actually increased post-flood.

Figure 6. Post-flood photos of fish monitoring sites along the Big Thompson River showing the effects of channelization.

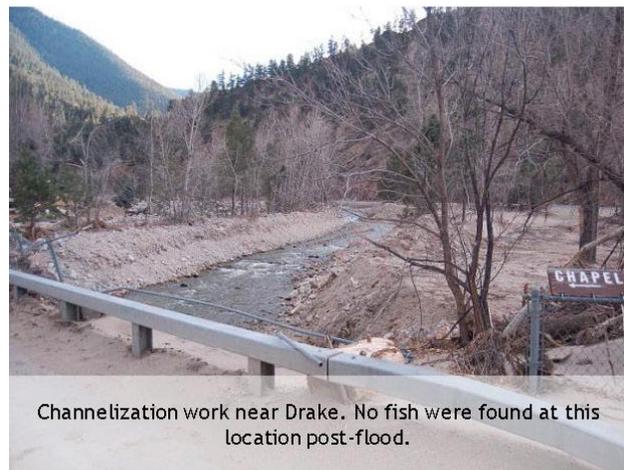
Channelization work near Drake. No fish were found at this location post-flood.

Channelization and armoring of the Big Thompson River reduced trout abundance by 90-100% at most locations surveyed (Table 2). For example, a section of the Big Thompson River at Drake contained 3,206 trout per river mile when surveyed in September 2012. No fish were found at this same location in November 2013 following channelization work (Figure 6). Farther upstream, near the Waltonia Bridge, trout abundance was reduced from 5,895 fish per mile in September 2012 to 130 fish per mile in October 2013. Sections of the Big Thompson River that were not artificially channelized fared much better in terms of trout abundance. The handicap fishing pier access site located near Highway 34 mile marker 72 yielded 3,769 trout per mile in October 2011. Following the 2013 flood, this same section contained 4,368 trout per mile, a 16% increase. Relatively little restoration work is needed for sections of the Big Thompson River where post-flood landscapes were not altered or channelized during post-flood reconstruction activities.

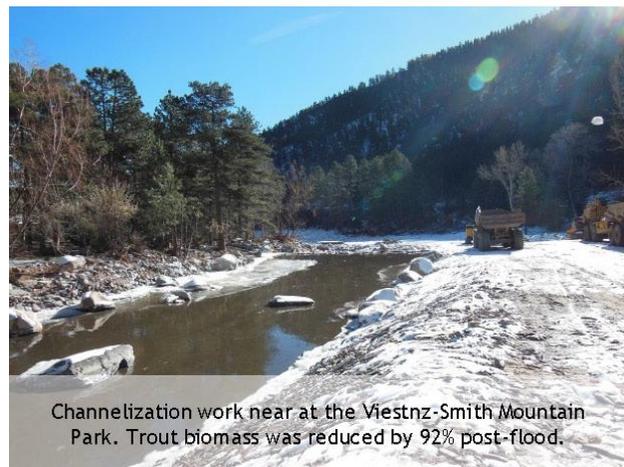
Channelization work near at the Viestnz-Smith Mountain Park. Trout biomass was reduced by 92% post-flood.

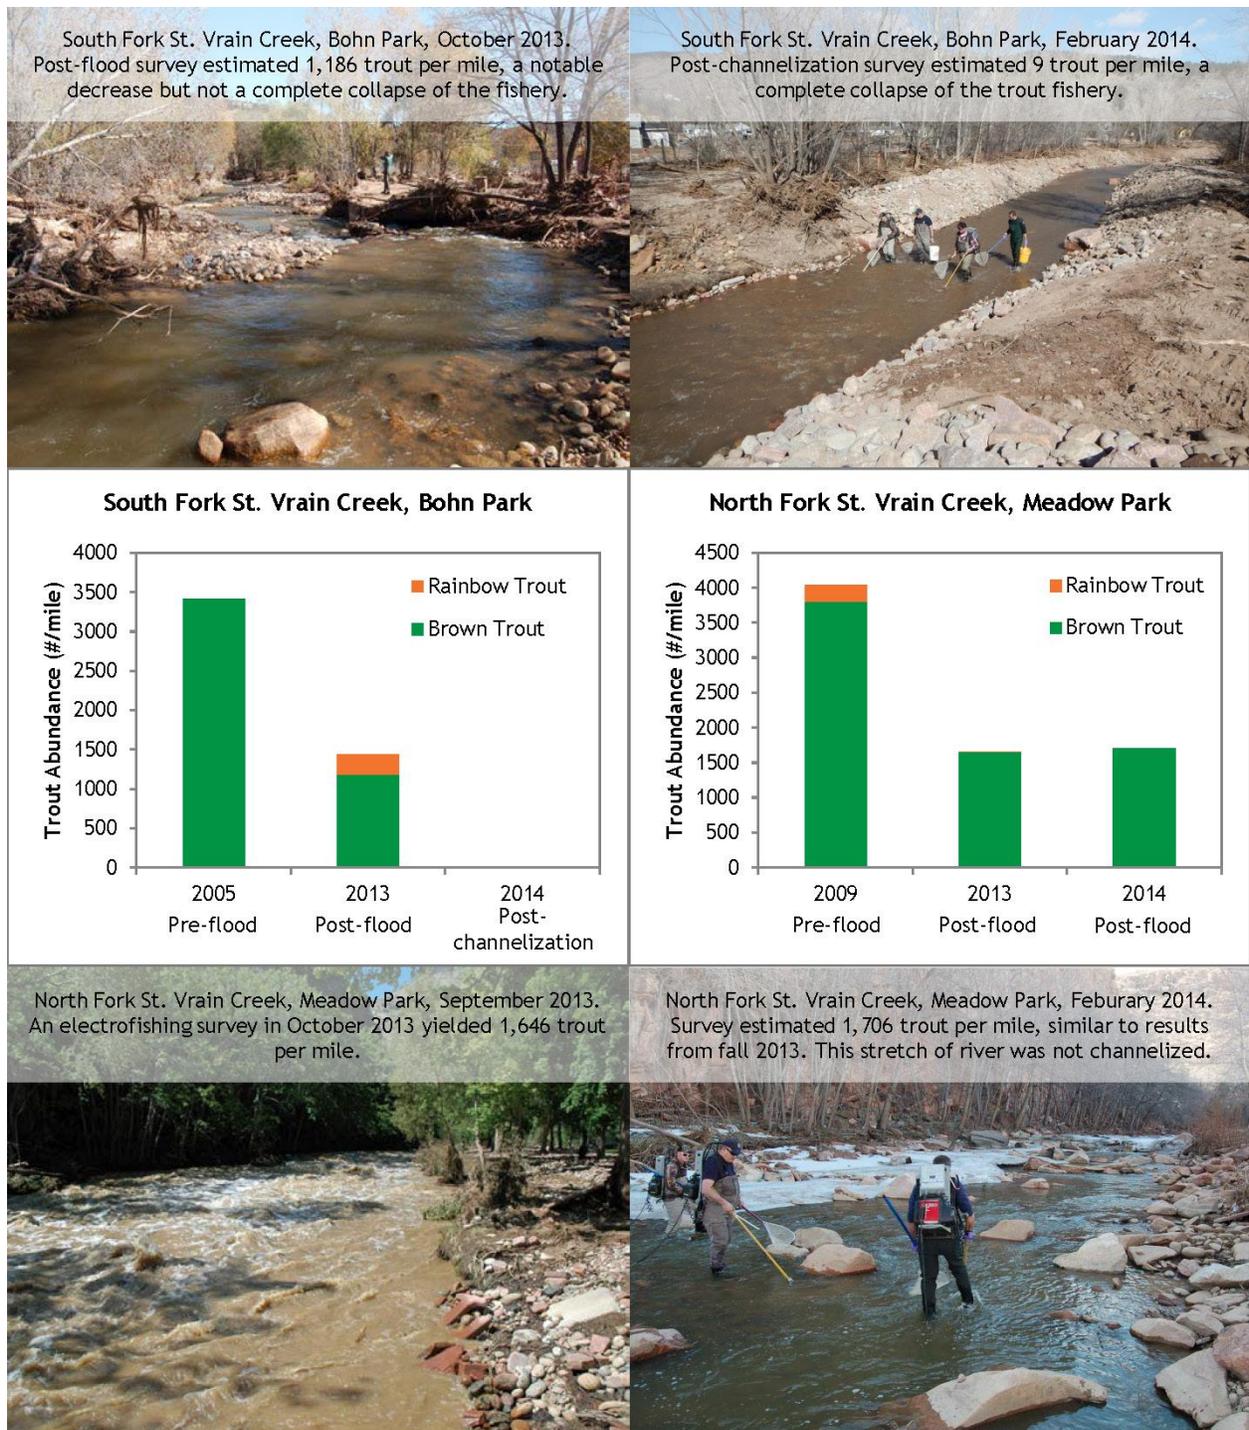
Figure 7. Changes in total trout abundance at Bohn Park, South Fork St. Vrain Creek, following the flood and subsequent channelization compared to Meadow Park, North Fork St. Vrain Creek, which was not channelized.

Decreased trout abundance was observed at both St. Vrain sites following the flood (Figure 7). Trout abundance at Bohn Park was previously estimated at 3,417 trout per mile in October 2005. Following the flood, trout abundance had decreased to 1,442 trout per mile in October 2013, representing a 58% decline for the previous estimate. Following post-flood channelization work, the electrofishing survey at Bohn Park yielded a single trout, or roughly nine trout per mile, representing a 99% decline in trout abundance between the post-flood and post-channelization surveys. Unlike Bohn Park, the historical survey site at Meadow Park on the North Fork St. Vrain was not channelized and remained relatively unaltered following the September 2013 flood. At this site, trout abundance decreased from 4,033 trout per mile in September 2009 to 1,659 trout per mile in October 2013, representing a 59% decline in the fishery due to the flood. However, survey results indicate that the fishery remained stable after the flood as 1,706 trout per mile were observed in February 2014. Although high flows observed during the flood impacted fisheries, these results suggest that drastic channel alterations during post-flood reconstruction further degraded fisheries in the Colorado Front Range. CPW will continue monitoring efforts to further evaluate the effects of both the 2013 floods and post-flood reconstruction on fishery resources in flood-impacted rivers.

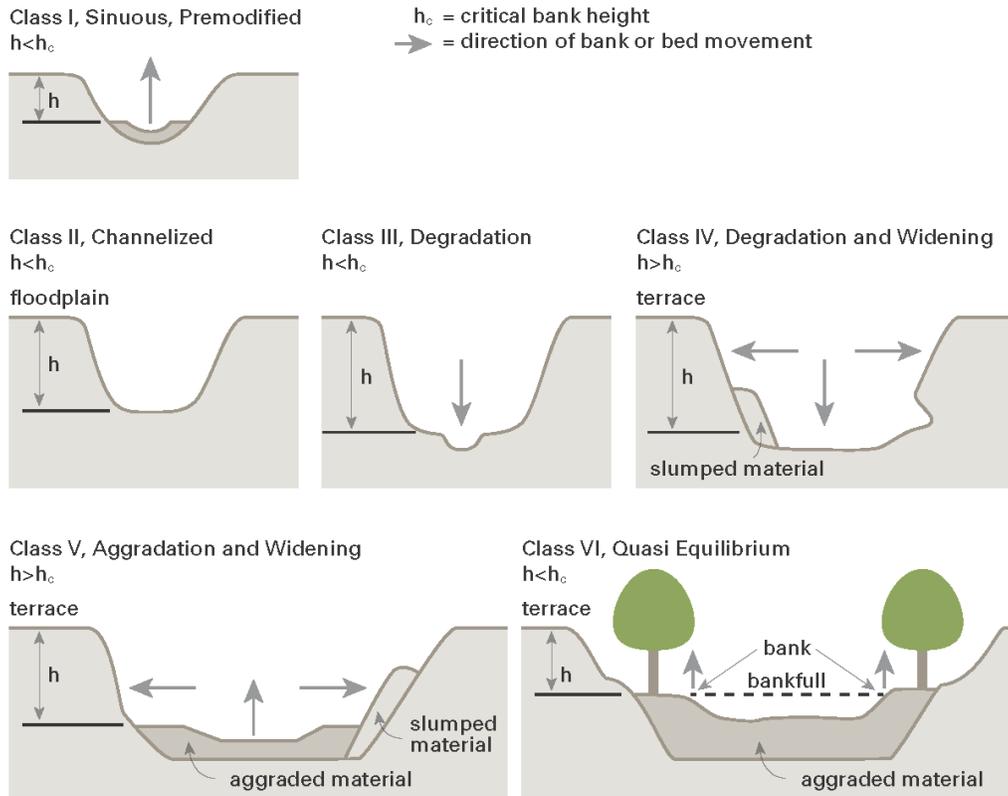
Figure 8. The Simon channel evolution model (Harman et al., 2012).

Channel evolution models demonstrate that channelized rivers are not stable and that channelization will lead to degradation and widening followed by aggradation and further widening (Figure 8). Rip-rap is commonly used in an attempt to prevent the natural evolution of channel morphology, but rip-rap can become mobilized or undermined during floods, as observed during the 2013 floods. We hope that bank stabilization measures can be utilized in a manner that supports stream functions, while both creating quality habitat and reducing debris accumulation at bridges. There are many stream restoration techniques, such as toe-wood or log-vanes, that utilize LWD to stabilize banks and create

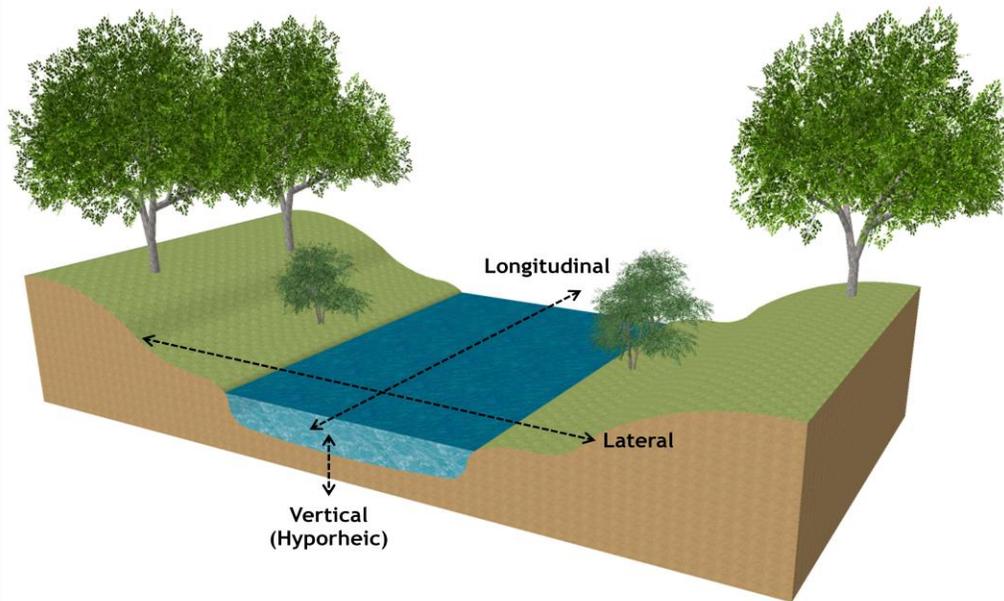
Figure 9. The three dimensions of habitat connectivity in a functioning river system.

Habitat connectivity is vital component of a functioning river or stream. There are three dimensions of habitat connectivity: longitudinal, lateral, and vertical (Figure 9). Longitudinal connectivity relates to connectivity between upstream and downstream reaches, lateral connectivity implies connectivity between the active channel and floodplain, and vertical connectivity pertains to connectivity between the active channel and hyporheic zone. Despite aforementioned issues with fish passage, re-connecting upstream and downstream reaches should remain an important goal for stream restoration along the Colorado Front Range. Longitudinal connectivity allows fish and other organisms to migrate upstream or downstream. Migration is a vital component of many species life cycle. Over a typical life cycle, fish seek out a variety of habitat conditions depending on their life stage, season, and environmental variability, among other factors. Should their local habitat patch become degraded from land use, point-source pollution, or climate change, fish and other organisms require access to habitat conditions found upstream or downstream. Lateral connectivity is also important for fish, as many species utilize the low velocities found on inundated floodplains for both refuge and migration. Therefore, it is

important to design channels that inundate their floodplains on a frequent basis, every 1-2 years. This multi-stage channel design supports a variety of river functions, including channel maintenance, exchange of nutrients and sediment, healthy riparian corridors, groundwater recharge, and energy dissipation during floods.

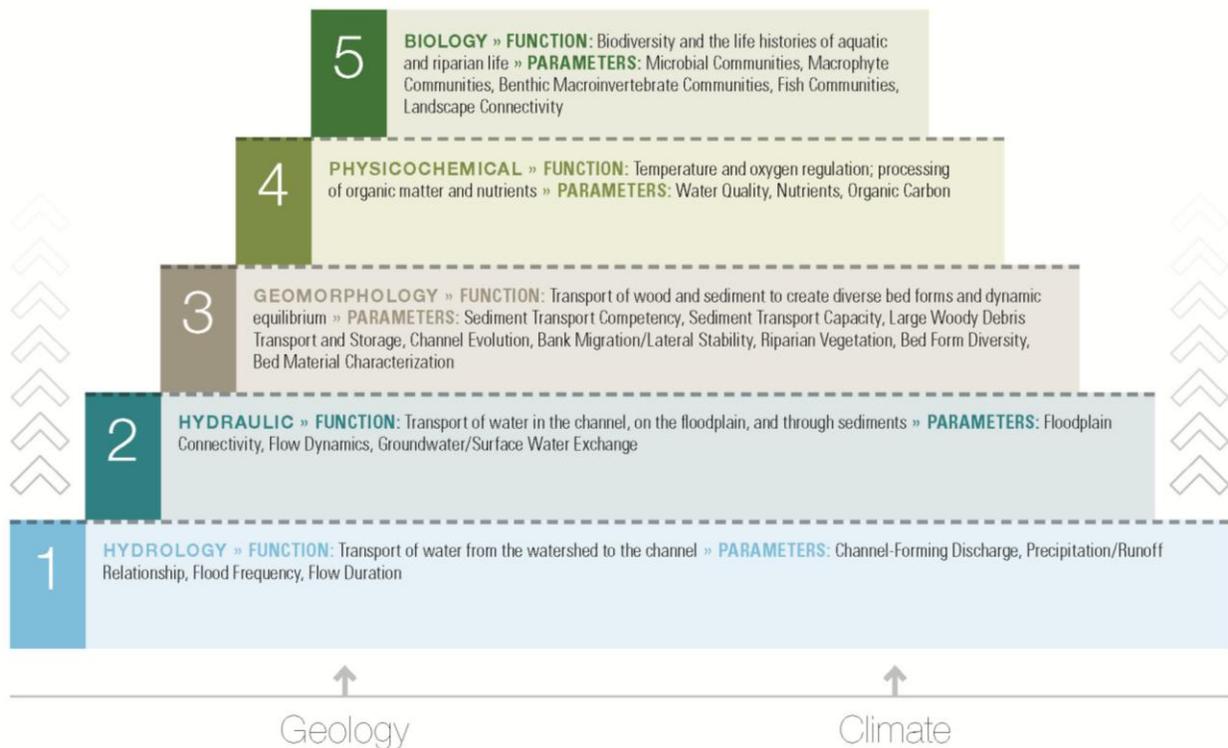
Figure 10. Functions and parameters associated with the each level of the Stream Functions Pyramid (Harman et al., 2012).

Guidelines for improving stream functions are detailed in the Stream Functions Pyramid (Figure 10; Harman et al., 2012). The Stream Functions Pyramid is a simple, conceptual framework based on the premise that all streams share common characteristics and functions. Hydrology and hydraulic processes provide the foundation for all stream functions, followed by geomorphologic, physiochemical, and biological functions. The pyramid captures the hierarchical nature of these functions and is a valuable tool for conducting stream assessments, developing project goals and objectives, and identifying approaches to restoration. We encourage state and federal agencies that are responsible for emergency reconstruction to consider the Stream Functions Pyramid when conducting exigent repairs after a major flood. By utilizing approaches to emergency flood response that support stream functions and ecological lift, we could not only improve the condition of our rivers, but also reduce costs associated with “permanent” stream restoration efforts following a major flood.

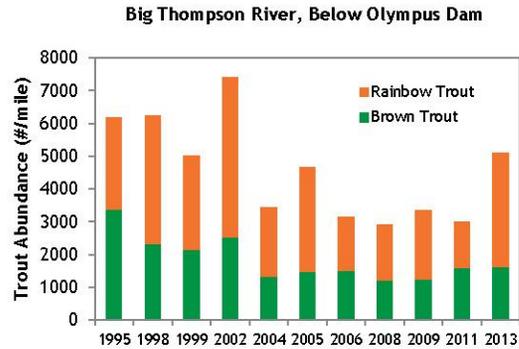
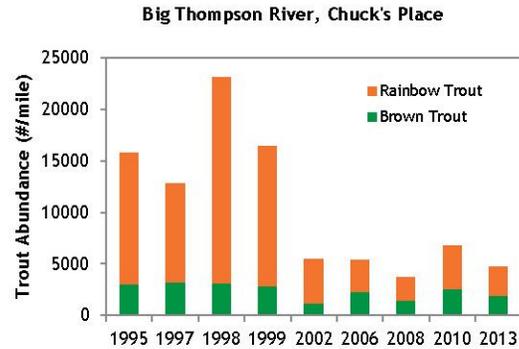
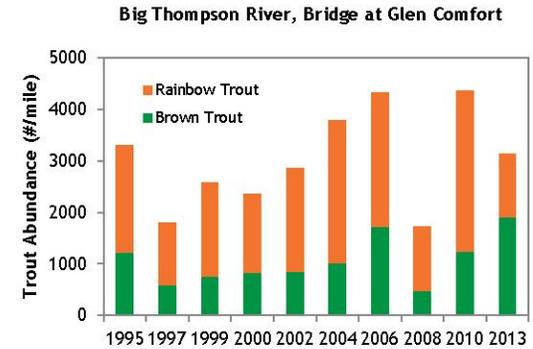
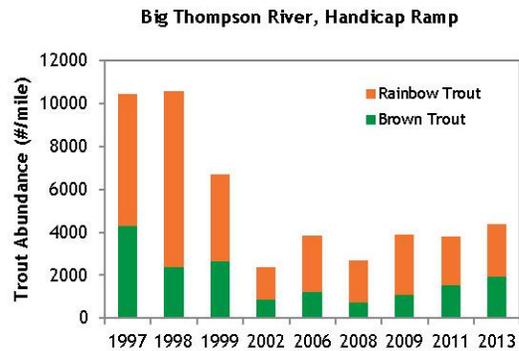
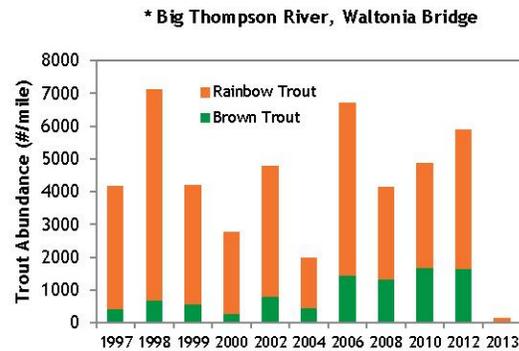
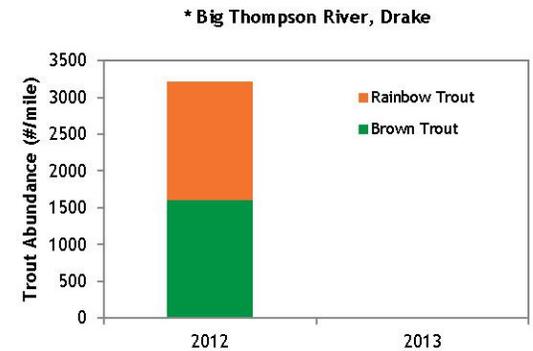
Appendix B

Trout abundance data (#/mile) for monitoring sites along the Big Thompson River. Notes: * denotes locations where post-flood channelization occurred in 2013; scale for abundance varies among sites.
