**Northern Water**

# **Fires, flood risk, and water quality**

GRAD 592 Guest Lecture

Esther Vincent, P.E.

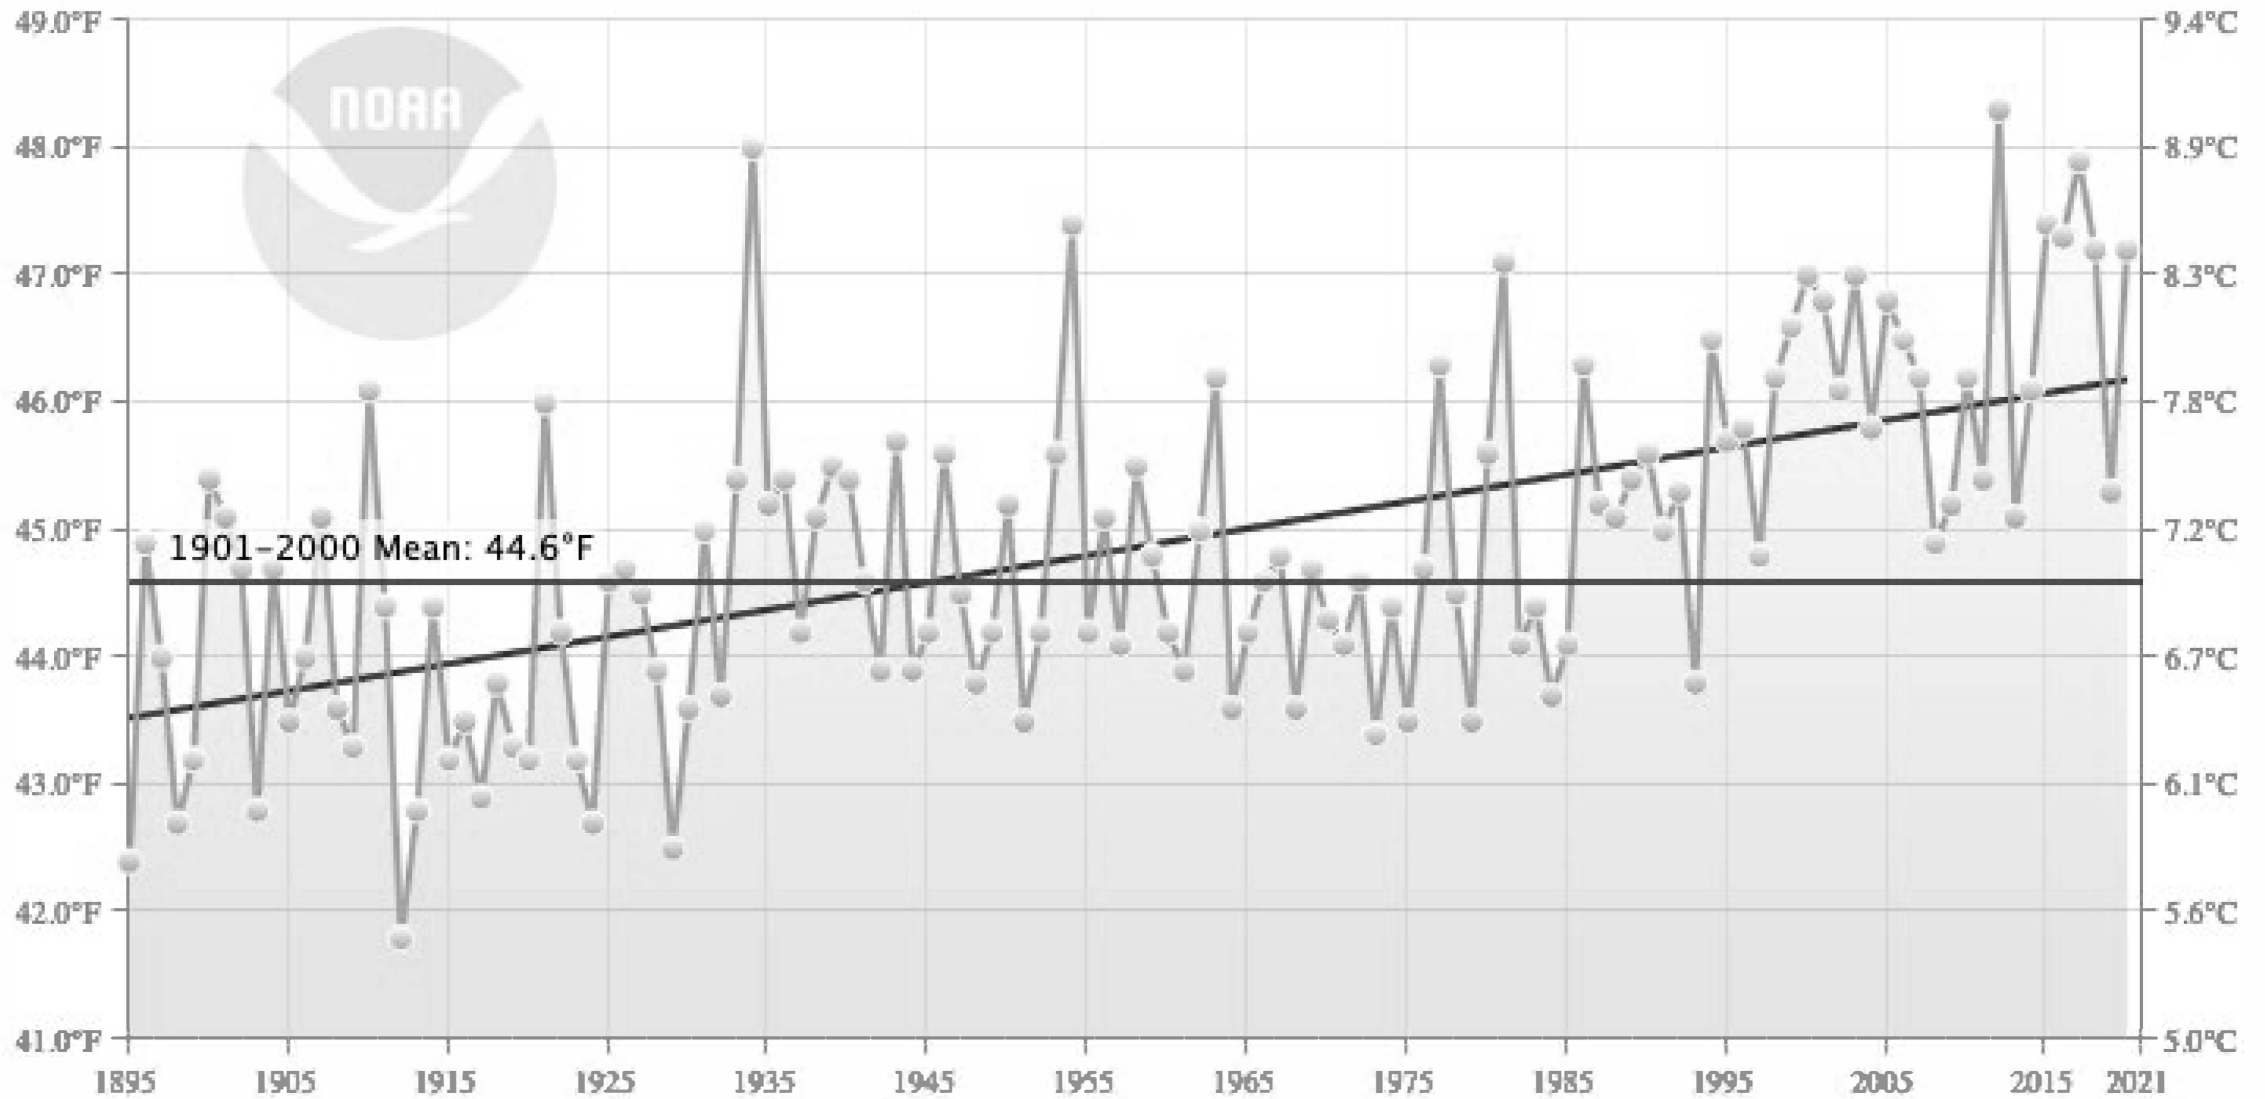
# Colorado Average Temperature

January-December

— 1895-2020 Trend  
(+0.2°F/Decade)

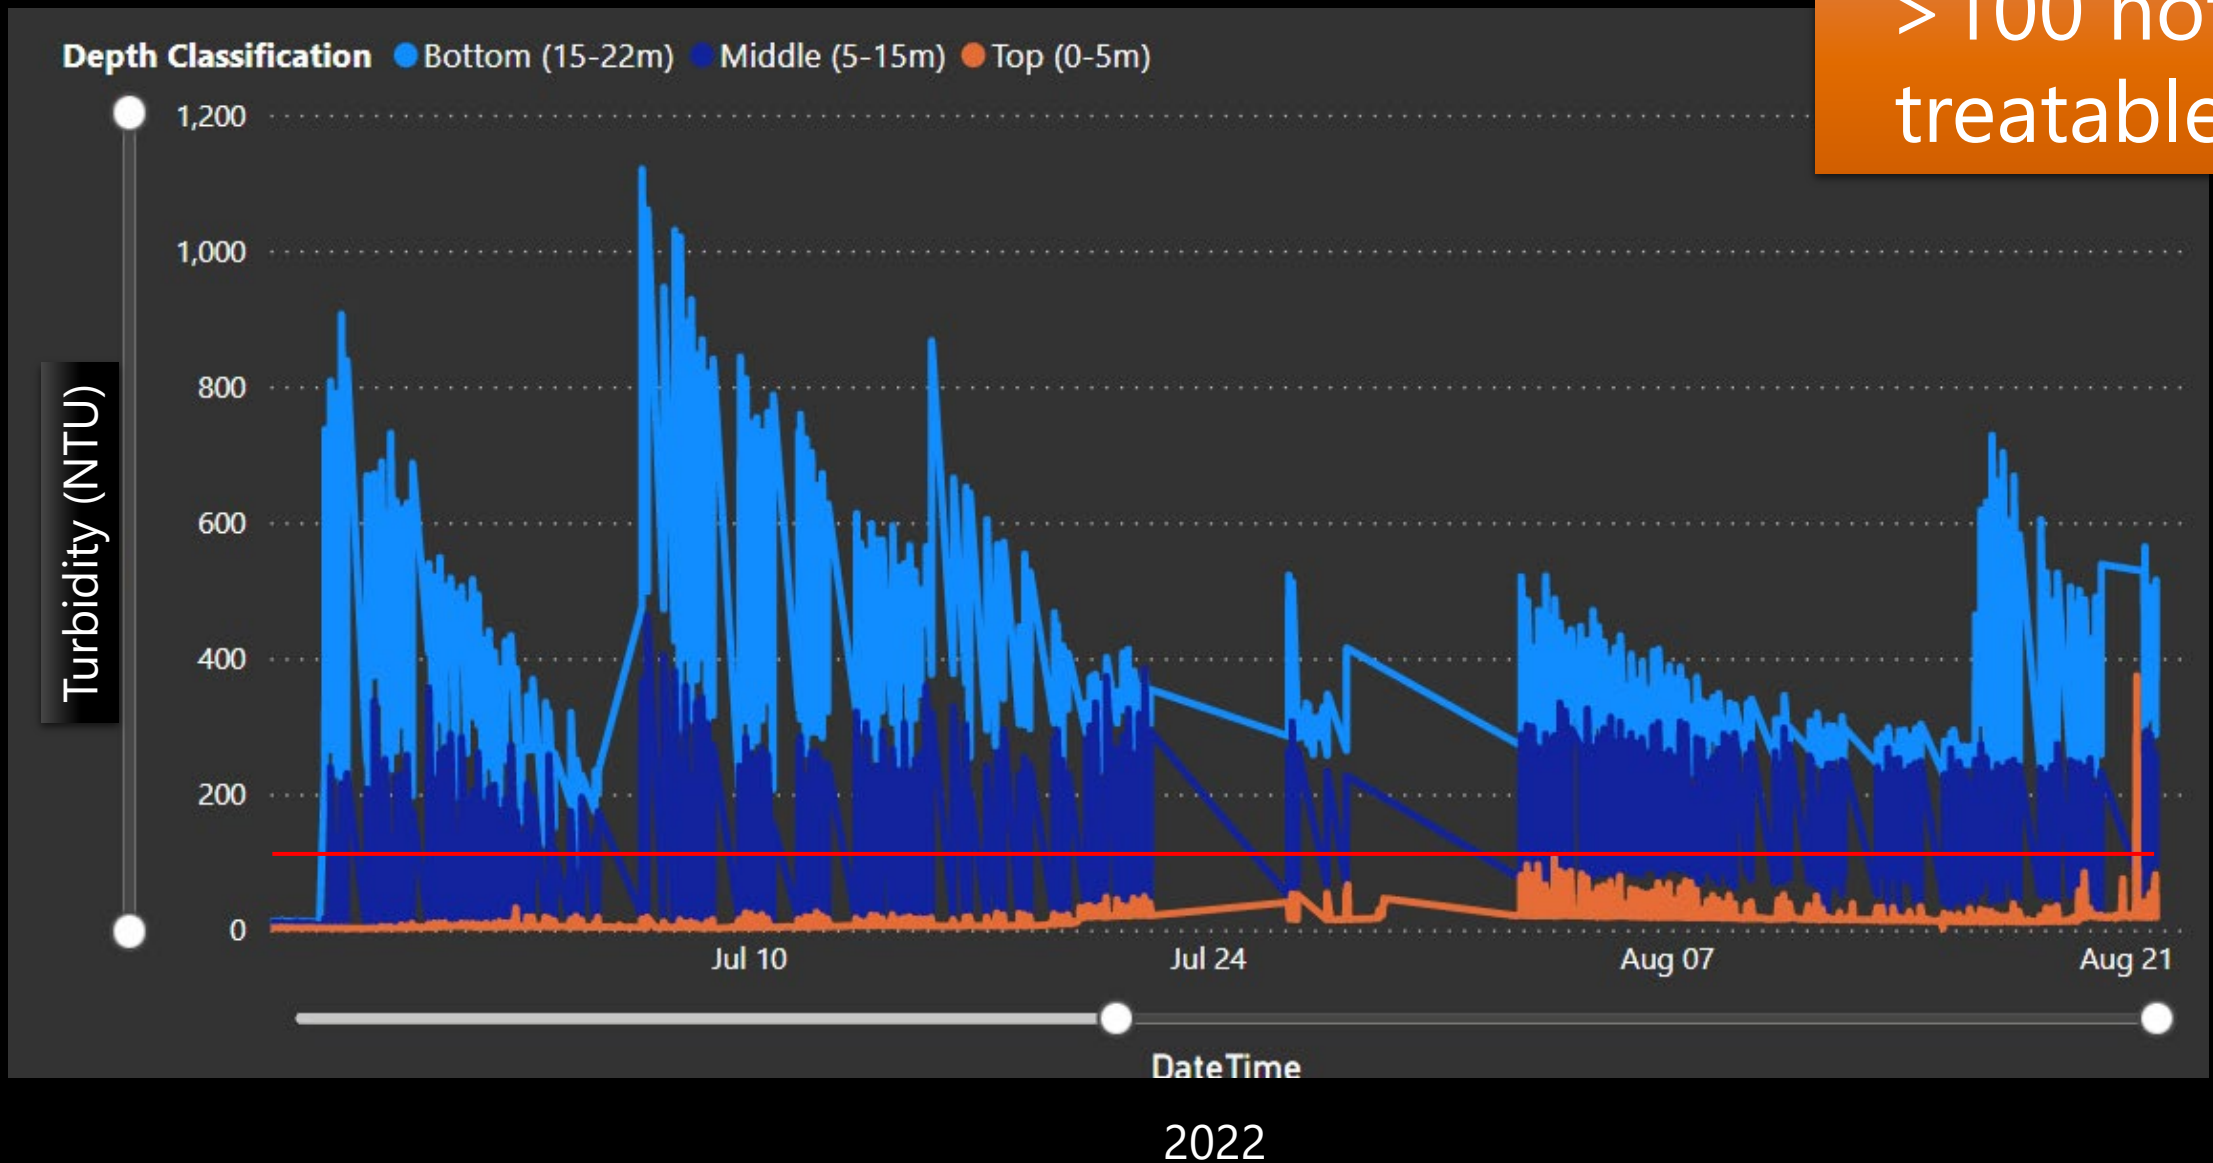
# Willow Creek Reservoir Turbidity (NTU)

> 100 not treatable
