GEOLOGIC FACTORS IN THE EVALUATION
OF WATER POLLUTION POTENTIAL AT
MOUNTAIN DWELLING SITES

L. K. Burns
D. R. McCrumb
S. M. Morrison

December, 1973

Colorado State University
Fort Collins, Colorado

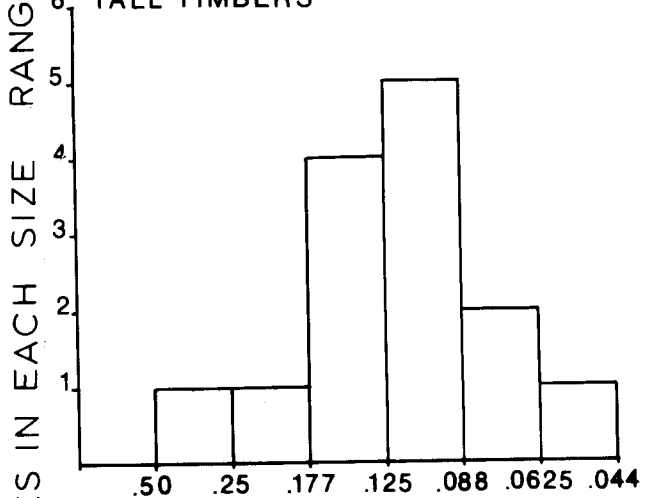
FIGURE 3. Histograms of effective grain sizes for soils in each of the study areas.

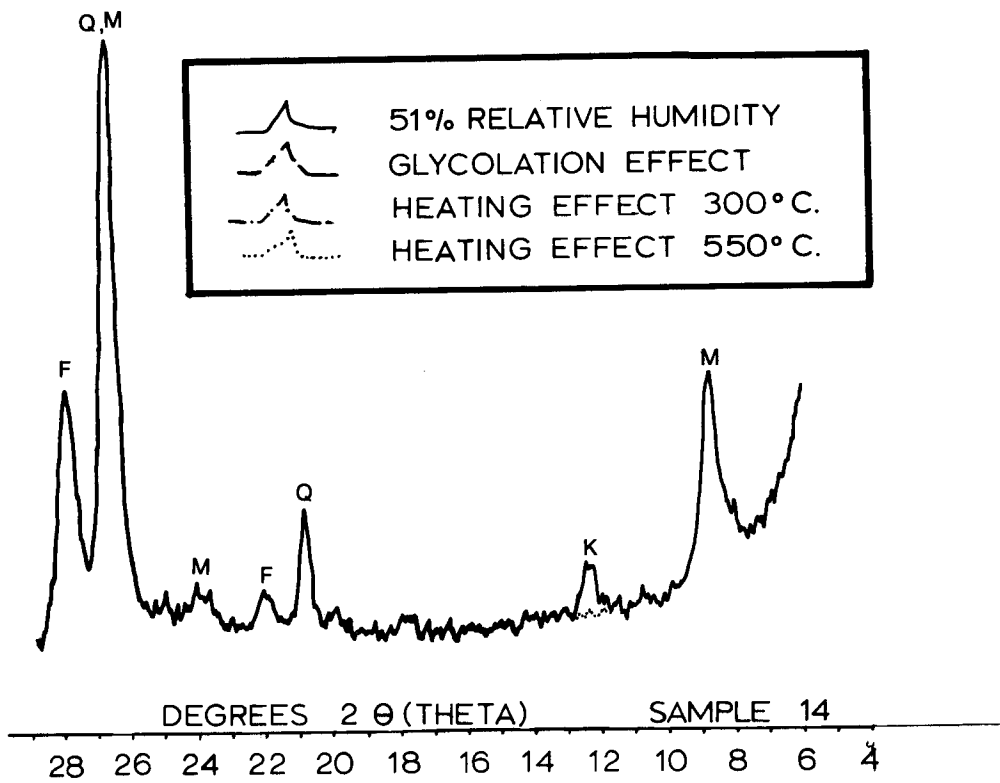
FIGURE 4. X-ray diffraction pattern of oriented clay mount typical of mountain soils containing non-expansive clays.

Q, quartz; M, mica; Ch, chlorite; F, feldspar;
K, kaolinite.

The diffraction scan following each of the above treatments was from 4° to 26° 2θ (two theta). The various clays present were determined from the combined diffraction patterns for each sample and are listed in Table 3. In addition, representative diffraction patterns were reproduced from several clay scans and can be found in Figures 4, 5, and 6, with the major peaks labeled as to the mineral which caused them.

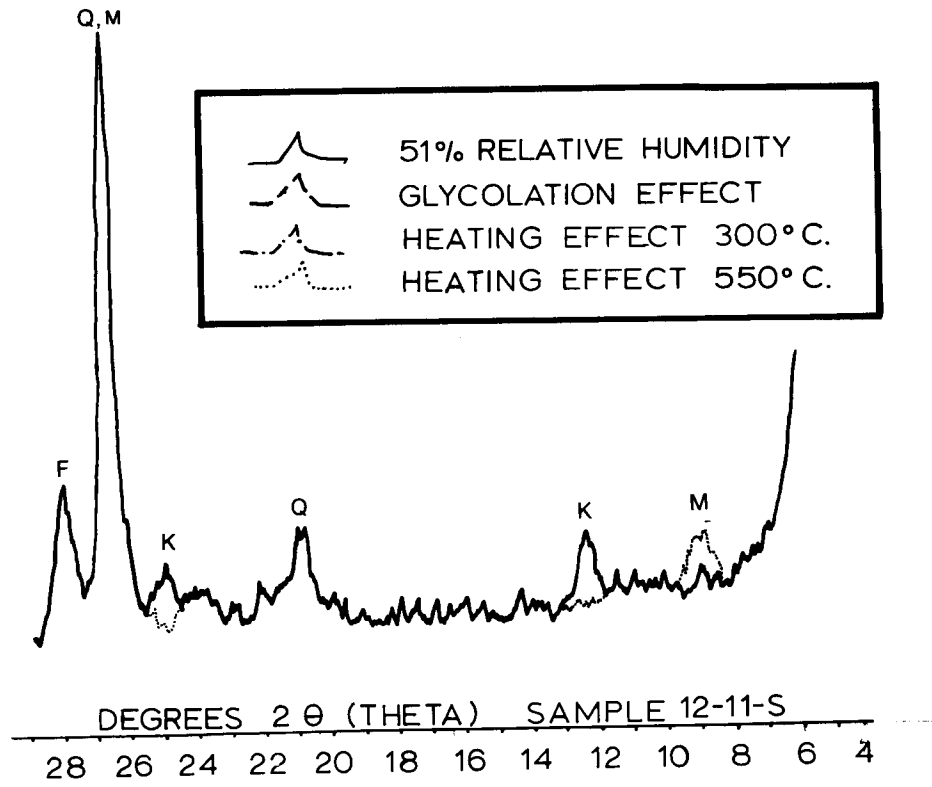
FIGURE 6. X-ray diffraction pattern of oriented clay mount typical mountain soil containing an expansive clay (27) and rock weathering product containing non-expansive clay (12-11-S).

Q, quartz; M, mica; Ch, chlorite; F, feldspar;
K, kaolinite; Ml, mixed-layered minerals containing montmorillonite.

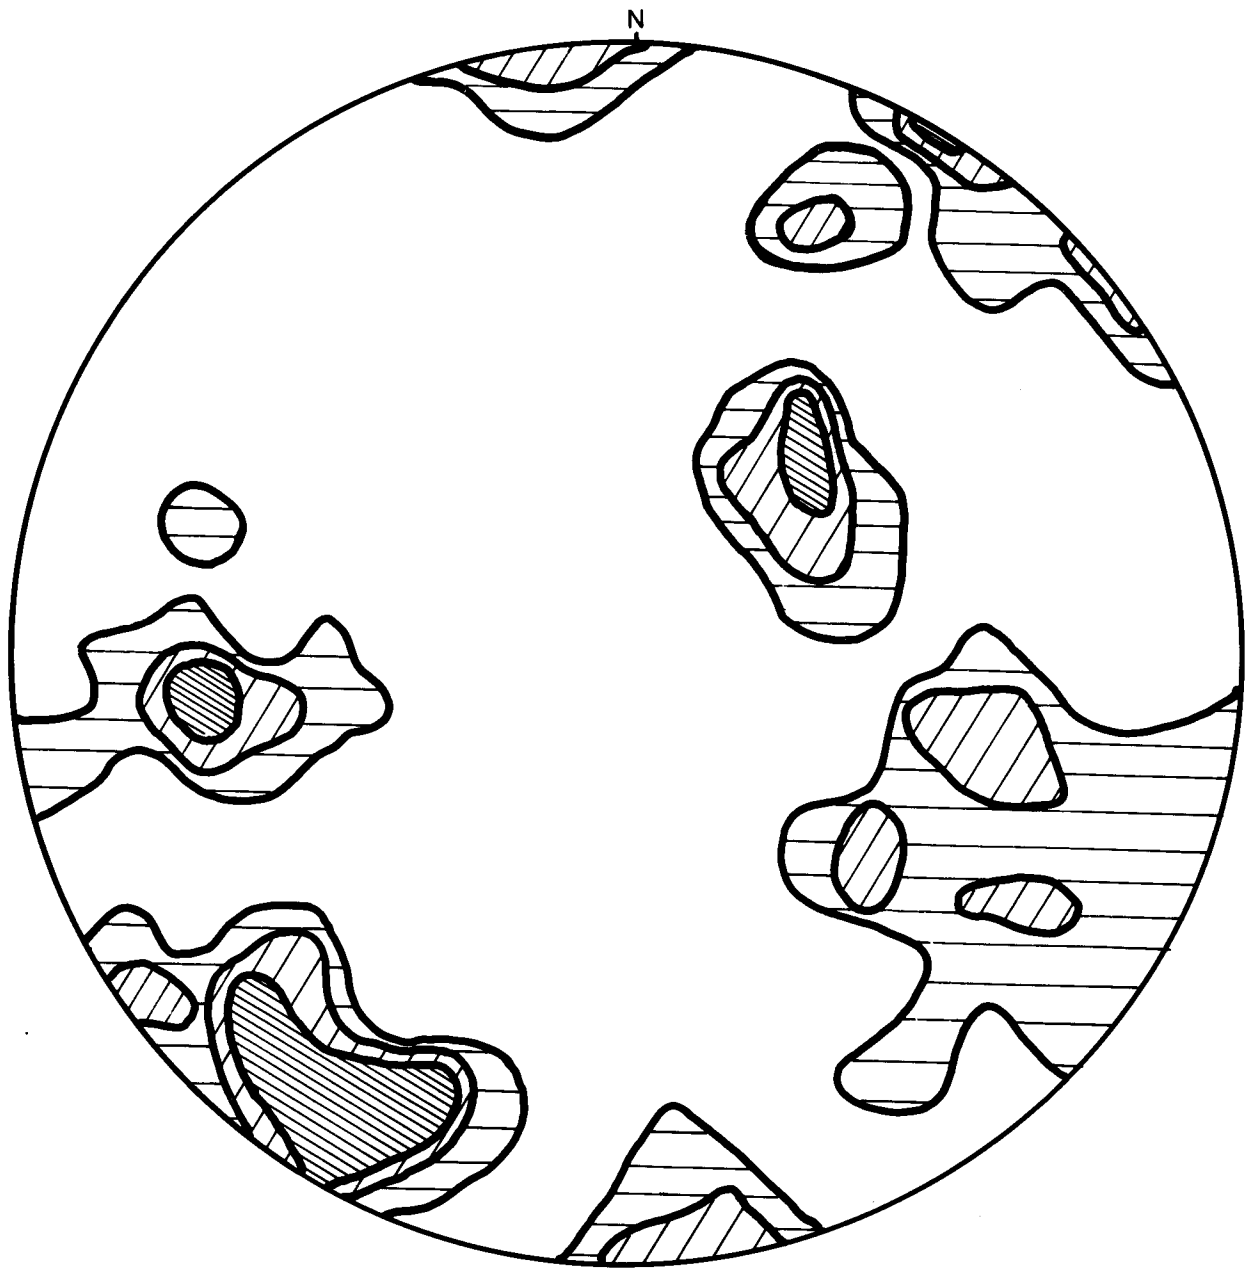
FIGURE 7. Pole plot diagram of Crescent Park joints.

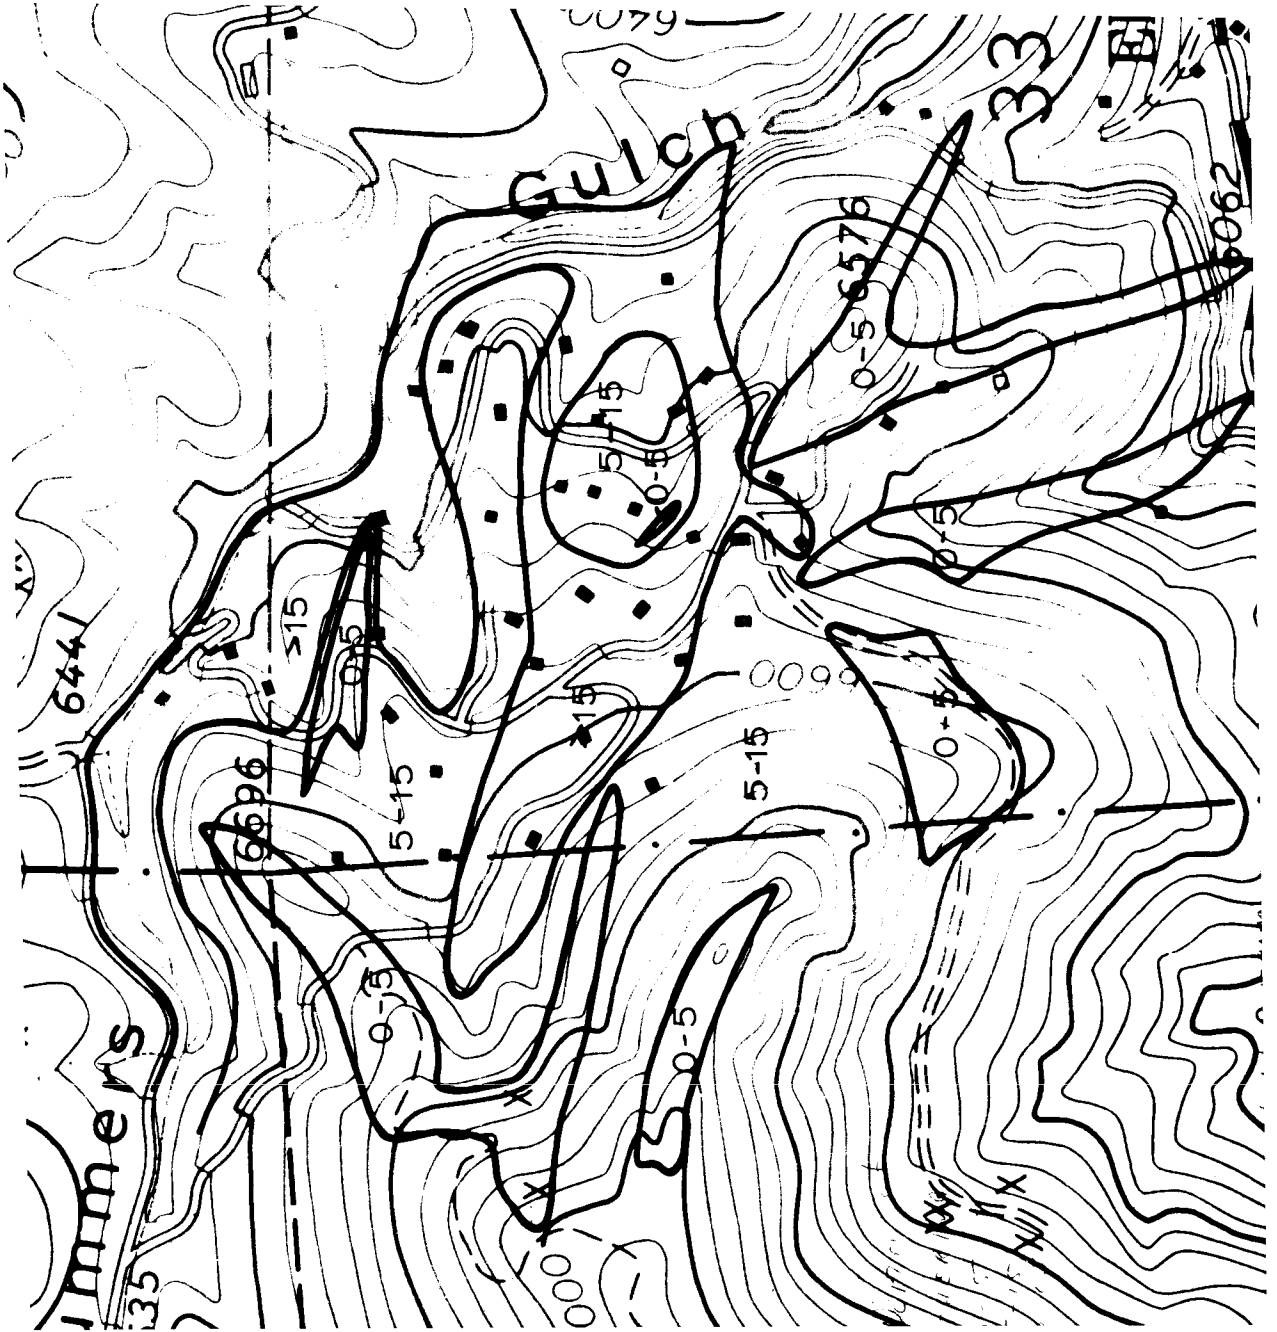
PLATE 14. Overlay indicating zones of intensely weathered bedrock for Tall Timbers. Note - categories for the suitability of weathered bedrock for use as soil absorption systems have not been established.
