# Urban Landscape Irrigation with Recycled Wastewater

Yaling Qian

March 2006

Completion Report No. 204

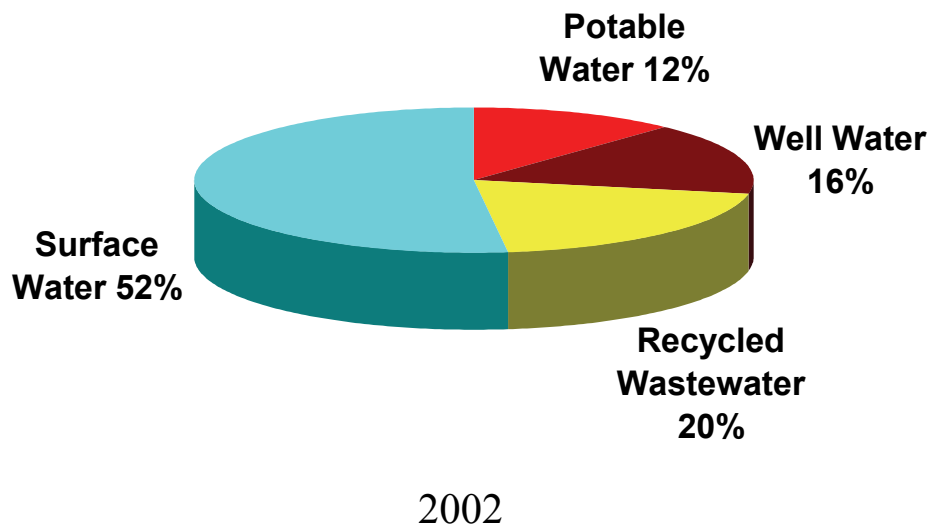
Fig. 1. Percentages of golf courses in Colorado to use particular irrigation water sources. (From Davies et al., 2003.)

Golf courses are by far the leading urban landscape users of recycled wastewater; mainly because golf courses have intensively managed turf (dense grasses utilize the nutrients in the wastewater) that requires a significant amount of water. A survey conducted in 1978 reported that 26 respondents across the country were using recycled wastewater. A more recent survey conducted by the National Golf Foundation (NGF) reported approximately 13 percent of golf courses (approximately 2000 golf courses) nationwide now use RWW for irrigation, and this increased to 34 percent in the Southwest (GCSAA, 2003). In Colorado, the use of RWW has risen significantly in recent years. Based on a survey conducted by Colorado State University and Allied Golf Associations of Colorado, there are about 260 golf courses in Colorado and 61 percent of the irrigation water came from surface water while 10 percent was from recycled wastewater in 2000 (Davies et al., 2004) (Fig. 1). In 2001 the percentage of surface water declined to 59 percent and recycled wastewater use increased to 16 percent. By 2002, surface water use had declined to 52 percent and recycled wastewater had increased to 20 percent (Fig. 1).

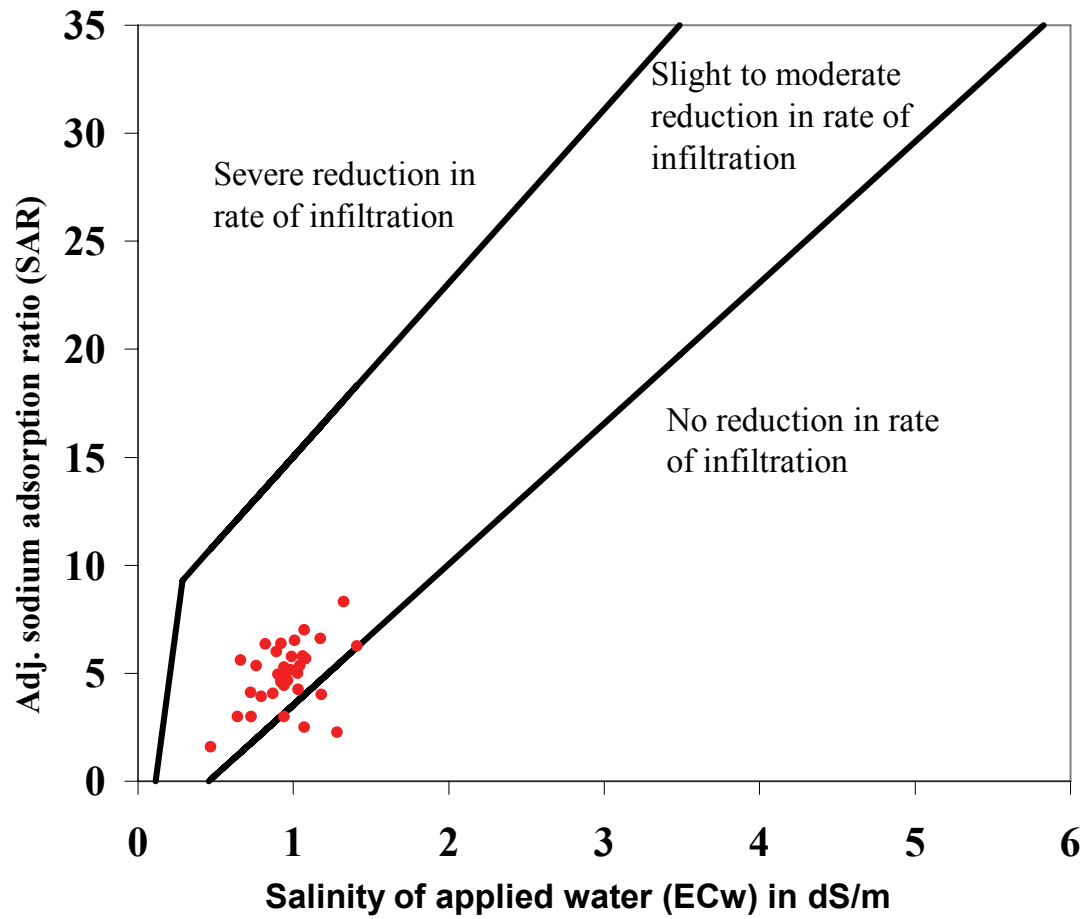
Fig 2. Relative rate of water infiltration as affected by salinity and adjusted sodium adsorption ratio of irrigation water (Adapted from Ayers and Westcot, 1985). The dots are the data points of water samples collected from Colorado water reuse sites.

Adjusted sodium absorption ratio (SAR) of recycled wastewater from reuse sites ranged from 1.6 to 8.3. Based on the interactive effect of salinity and sodicity on soil infiltration and percolation, most of the water samples collected showed slight to moderate effects on soil infiltration and permeability (Table 4 and Fig. 2). Additional management (such as Ca product topdressing or amendments and frequent aeration) is needed to mitigate these effects.

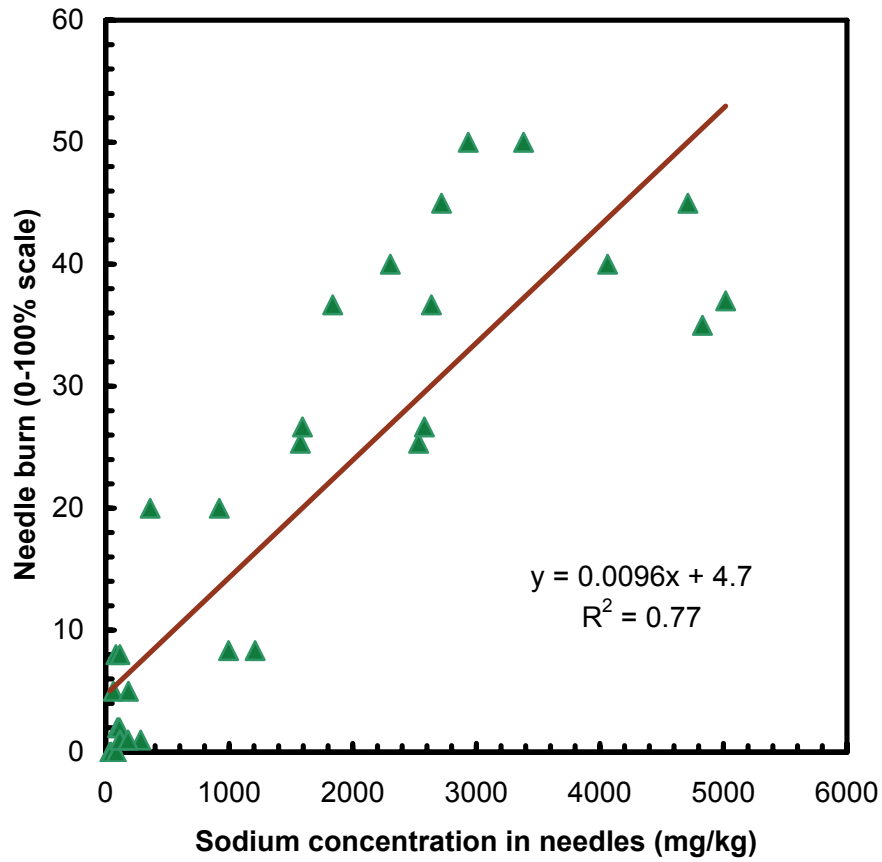
Fig. 3. Linear regression of the degree of needle burn and sodium concentration in needles of ponderosa pine subjected to recycled wastewater for irrigation.

Regression analysis revealed that needle burn was largely influenced by needle  $\text{Na}^+$  concentration with a linear regression coefficient of 0.77 (Fig. 3), indicating increasing needle burn was at least partially associated with the  $\text{Na}^+$  accumulation in the needles. When needle  $\text{Na}^+$  concentration increased beyond 1500 mg/kg, leaf tip burn became visually apparent. In a study evaluating the impact of  $\text{NaCl}$  applied to highways for deicing on pines and cedars, Hofstra and Hall (1971) also found that the percentage of necrotic foliage and the percentage of  $\text{Na}^+$  and  $\text{Cl}^-$  in the leaf tissue were closely related.
